# THERMASTEEL, INC. FIRE TEST REPORT

ASTM E119 TESTING ON LOADBEARING ASSEMBLY CONTAINING THERMASTEEL WALL FRAME SYSTEM

M8525.01-121-24-R1

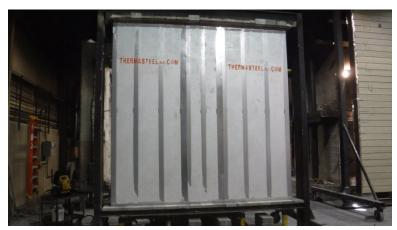
Photo No. 1
ThermaSteel Wall Panel Assembly Unexposed Face

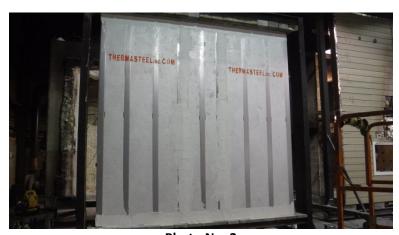
Photo No. 3

Joint compound and joint tape applied to steel track and panel joints (Unexposed Face)

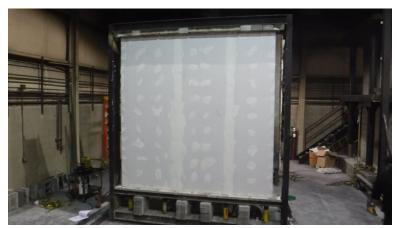
Photo No. 5
First layer Vertical Orientation Gypsum Installed (Unexposed Face)
